Hoffer Plastics
Elgin, Illinois

Island-Mode On-site Power

Peaker Services, Inc. Case Study

Extensive Digitization Controls Upgrade Gives Power Plant New Life

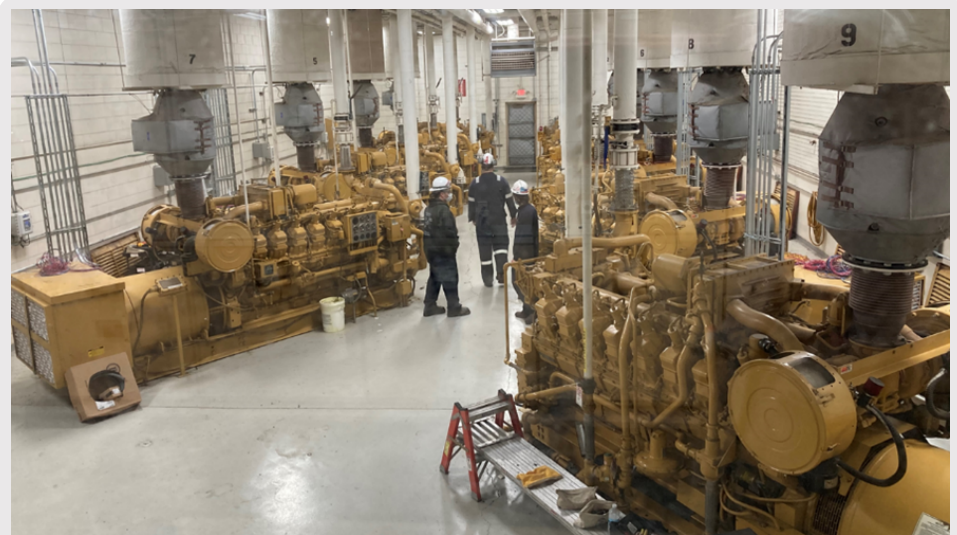
Fig. 1 Engine Gensets

Hoffer Plastics installed nine CAT 3516A natural gas engines in 1994 for onsite power and cogeneration. The power plant had a number of reliability and safety problems including: obsolete and outdated switchgear and ignition systems, older mechanical governed engines, brittle wire-harnesses, and a knock system that could only detect major events. The goal of the upgrade was to provide facilities with unmanned reliable island-mode power that could start in minutes.

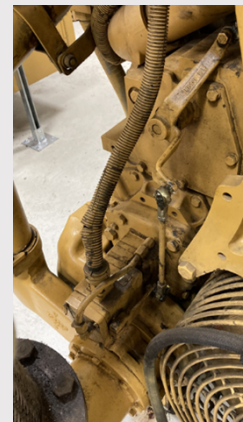
The engine throttle was controlled with an engine driven and engine oil supplied hydraulic actuator through multiple bar linkages (Fig. 3, 4 and 5):

Each of these non-linear throttle linkages, couplings, and bearings were difficult to set up, needing regular greasing. Compared to modern electronic throttles, these governors were limited in adjusting for changes in load or environment.

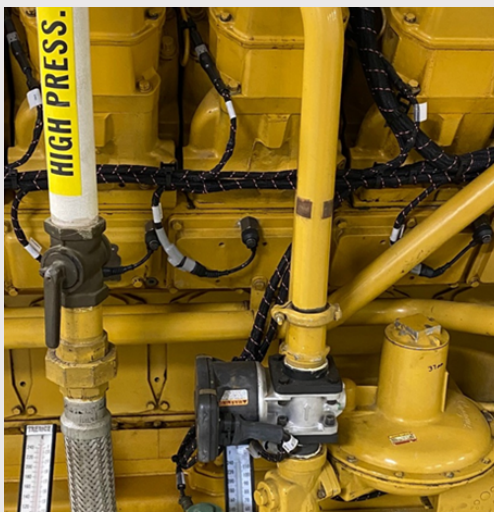
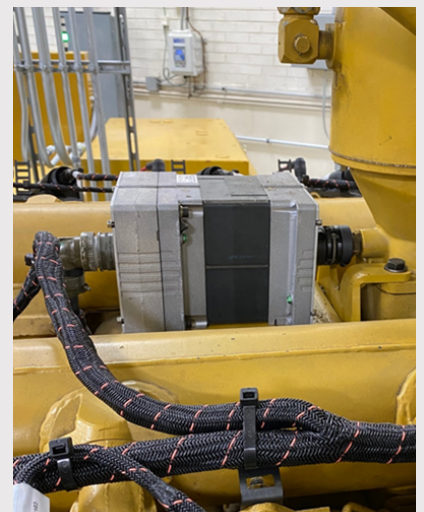
The throttle control was upgraded to a ProAct™ electronic actuator, and the air fuel ratio trim valve was replaced with an F-Series electronic trim valve (Fig. 6 and 7).

The new ProAct™ throttle and F-Series fuel trim valve (Fig. 6 and 7) result in exceptional air/fuel ratio control, providing the controller with the ability to continuously adjust for fuel and environmental changes. These actuators are controlled by LAT (limited angle torque) motor actuators. These brushless torque motors include on-board software and digital intelligence to monitor and diagnose problems while the engine is running.

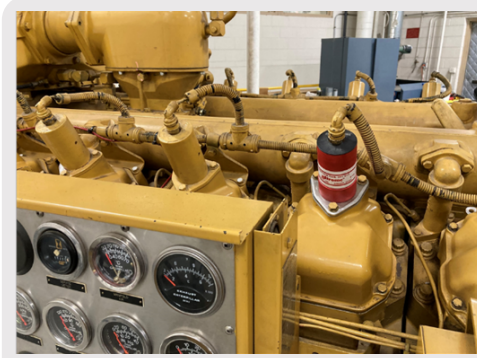
Fig. 8

The ignition system was an Altronic magneto system (Fig. 8). A number of coils were replaced over the years, and the ignition wire harness was brittle and cracked. In addition, the low energy capacity discharge ignition system required a time-based spark plug replacement strategy.

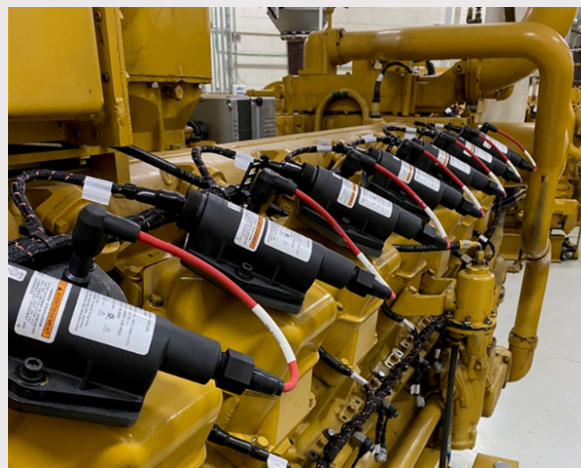
Fig. 9

The ignition system was replaced with Woodward coils and high energy PWM Digital Ignition system (Fig. 9).

The brittle harnesses were replaced with robust, custom-fit wire harnesses. These harnesses were fabricated and tested on the Peaker Services test stand before shipment to the site. This resulted in a simple, reliable installation.

The high energy Woodward Ignition system is the latest PWM technology, which allows the amount of energy supplied to the spark plugs and the spark profile to be optimized. The new ignition system is calibrated on the Hoffer engines for optimal combustion performance. The ignition system will automatically modify the spark duration when required for peak performance. Additionally, misfire detection and indication of spark plug condition are included in the engine control, with an alarm visible from the control room.

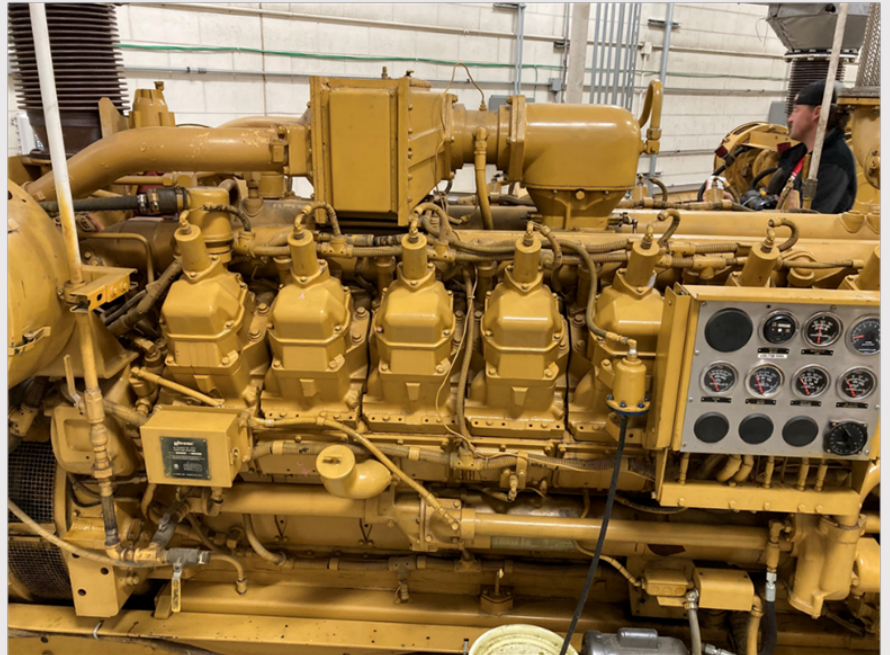
Fig. 10

The OEM engine included one knock sensor on each bank of 8 cylinders (Fig. 10).

The original knock system could only detect major events—i.e. events that result in a system shutdown.

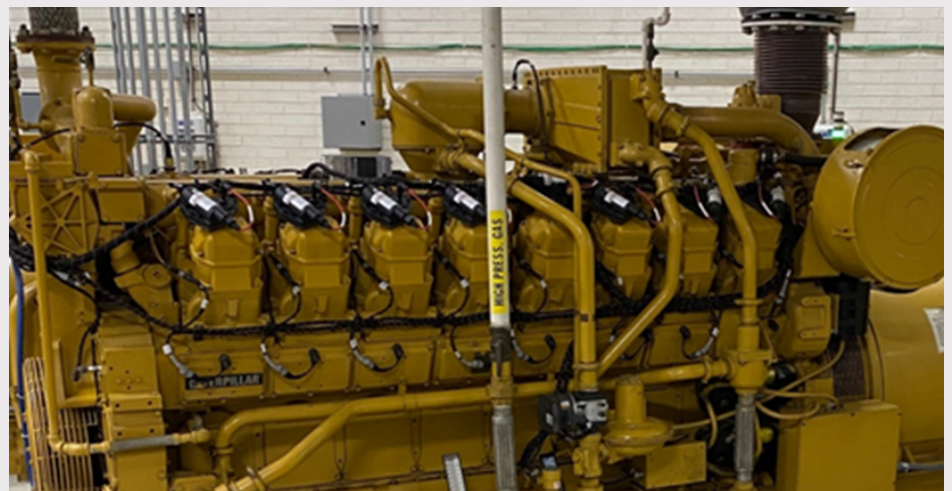
Fig. 11

The upgraded system included one knock sensor per cylinder for a total of 16 knock sensors per engine (Fig. 11).

The knock sensors on each cylinder are monitored by the advanced Woodward engine controller. Feedback from the knock sensors allows the engine timing to be continuously adjusted for optimal control, with load derating or engine shutdown triggering in the case of severe knock.

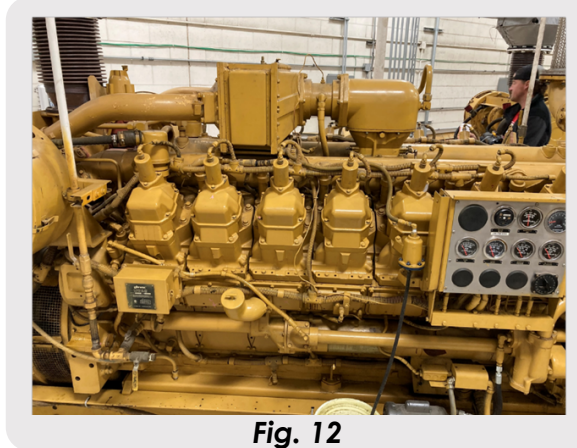
Fig. 12

The majority of the original engine monitoring was on a gauge panel located on each engine (Fig. 12).

For many engine operating conditions, operators had to physically walk to each engine and read the gauge displays. In addition, the original displays blocked access to engine service areas.

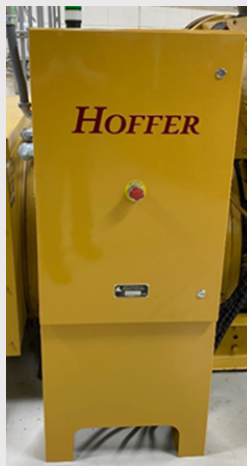
The upgraded engines include cabinets housing the Large Engine Controller, and all operating conditions and metrics can be seen at the control panel in the Control Room (Fig. 13, 14 and 15).

All operating conditions and metrics are easily visible at the control panel in the Control Room. Operators no longer need to walk to the gauge panels in the engine room to understand the operating parameters of the engine. Engine components are all more accessible due to removal of gauge panels.

The key operation features (temperature, pressure, power, etc.) are all monitored by the LECM (Large Engine Control Module), which optimizes operating conditions.

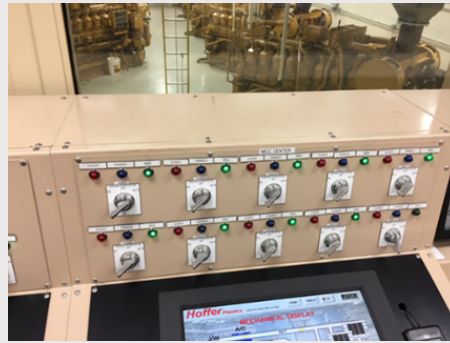
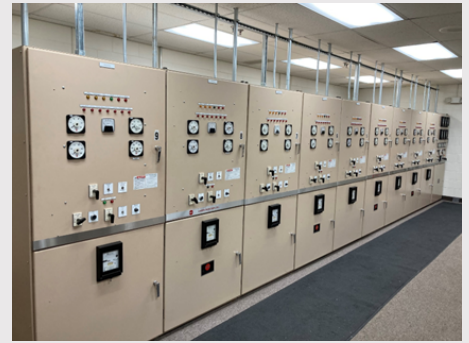
The original control room was outfitted with simple engine monitoring and an obsolete analog switchgear (Fig.16 and 17).

The control room SCADA had very little feedback or control of the engines, and the switchgear included analog controls that needed to be “tweaked” to maintain control.

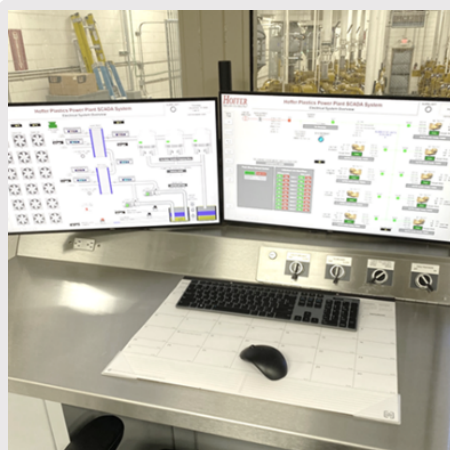
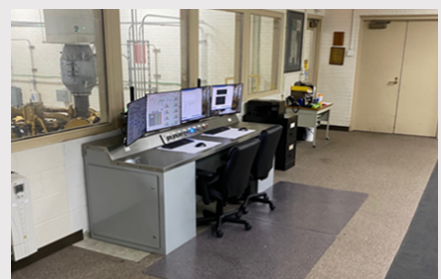
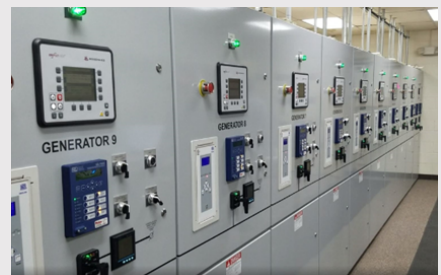
The switchgear panels were replaced with door and back panels fabricated at Peaker Services’ Brighton facility. The panels were installed with the latest digital easYgen control and generator protection systems. A new SCADA control panel with integrated Balance of Plant PLC was fabricated for the control room to monitor and control the entire power plant (Fig. 18, 19 and 20).

The upgraded digital power management controls provide automation, power protection, synchronization, load control, and other key monitoring parameters.

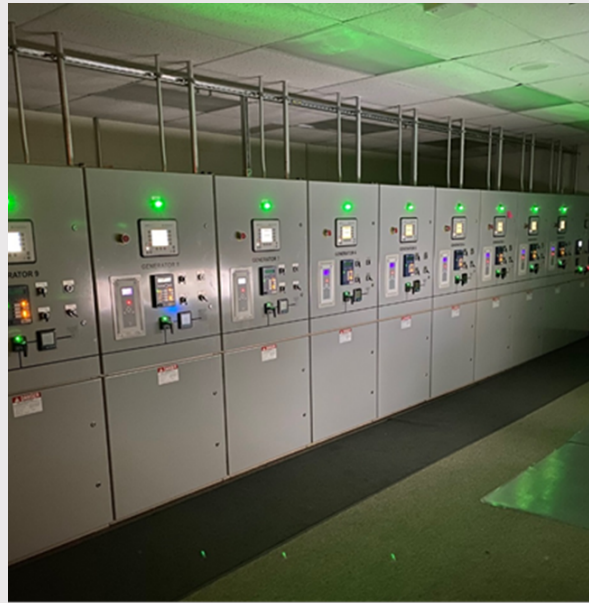
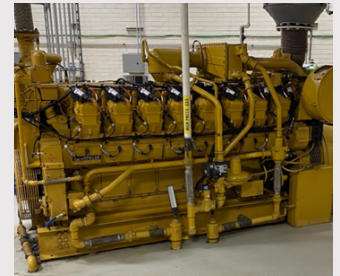
Upgrade Overview

Updates to the Control Room allow direct management of the Engines, Battery Packs, and Generator controls in a simplified manner.
